AGAM-P (M) (23 Jul 68) FOR OT RD 682187 8 August 1968
SUBJECT: Operational Report - Lessons Learned, Headquarters, 93d
Engineer Battalion (Const), Period Ending 30 April 1968

DEPARTMENT OF THE ARMY
Headquarters, 93d Engineer Battalion (Const)
APO San Francisco 96530

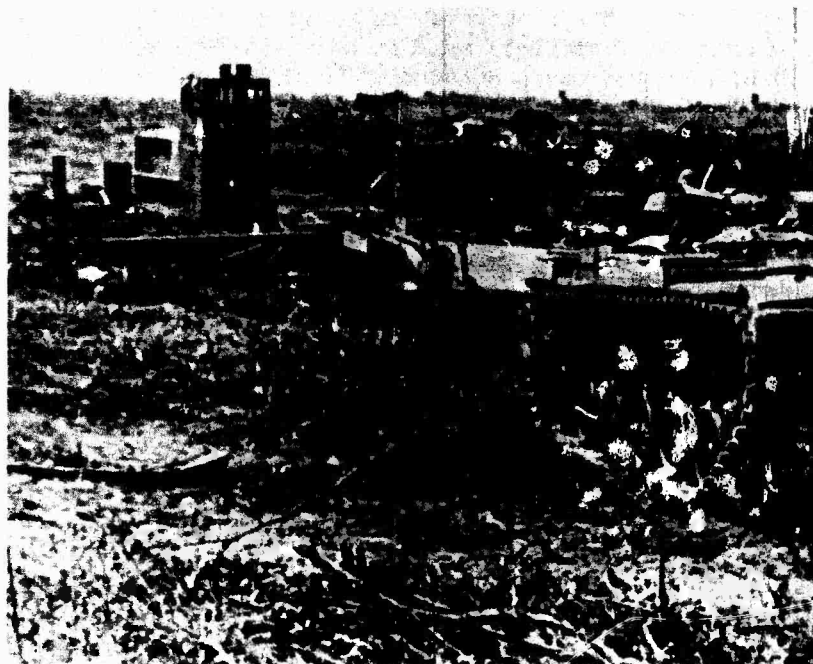
2. Surface Conditions: It was noted that working in the same general area and in the same type of soil this reporting period and last reporting period, that the moisture content of the soil was significantly lower due to the dryness of the intervening months. It was also noted that with the lower moisture content, the soil was much more cohesive and presented greater resistance to the rotation of the drums. This fact was evident in that motor failure due to overload and overheating was greatly increased during this reporting period. The crushers exhibited a tendency to "burrow in" and settle into unstable soil areas. The unbroken curved configuration of the amphibian drums then acted like huge suction cups and created a resistance to rotation greater than the drive motors were able to overcome. A typical sample of this soil type was taken from the Long Binh area for testing. Test results (see figure 1) indicate the soil is a CH classification soil, with a plastic index (I) equal to 27.3. Photograph No 10 shows the depth to which the machine buried itself in this material. Use of the AVLB and Light Track Recovery Vehicle, in the arrangement shown in photograph No 10 was unsuccessful in extracting the machine. A single M88 VTR was later able to extract the machine working by itself.

The lower ball of the rear tug assembly contributed greatly to the resistance offered by the machine to extraction. Modification and redesign as suggested in the initial evaluation to both the rear tug assembly and the drums would have a definite advantage over the present configuration under these conditions. The 12 point split drum would decrease the suction effect on the soil and the higher tug assembly would not be buried to a depth sufficient to cause resistance to extraction.

Photograph No 10 (Long Binh) Tactical Tree Crusher partially buried due to unstable soil conditions. Attempted extraction by scheme shown here was unsuccessful. A single M88 VTR was later used to extract machine.
